**Report on the Analysis of Physical and Chemical Properties of Soils
Sampled from Two Selected Sites in Campus**

20 December 2013

Date of Sampling 4 December 2013

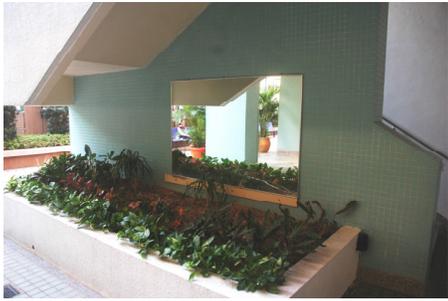
- However, there is a great contrast of soil moisture. In Site B, where plants grow well, the soil water content is 22.5%; on the other hand, that in Site A is 9.6%. In an ideal soil composition, water shall take around 25%. The low soil water content in Site A shows that moisture is one of the factors leading to the poor growth of vegetation.

- Soil depth seems to be another crucial factor in limiting the growth of vegetation. It is found that the soil depth of the sites have a great difference. Where Site B has a depth of 10 cm, Site A has 6 cm. Such shallow soil may not be deep enough for vegetation to grow.

- It is recommended that more irrigation should be carried out on Site A. This helps increase soil water content, facilitating the growth of vegetation.
- Soil of Site A should be thickened so that there will be enough room for roots to extend.
- Adequate sunlight is important to the growth of vegetation for photosynthesis. The existing mirror intends to reflect sunlight but it turns out not to be quite helpful. Additional engineering measures shall be taken to install light source as a substitution.
